Many different spacecraft materials were flown as part of the Materials on International Space Station Experiment (MISSE). MISSE was exposed to the low Earth orbital environment of atomic oxygen, ultraviolet radiation, thermal cycling, and hard vacuum. A number of polymer samples did not survive the atomic oxygen attack. Mass and thickness loss measurements indicate the durability of the remaining polymeric materials to withstand the space environment. Results from the one-year exposure on MISSE-3 and MISSE-4 are compared to those from the four-year exposure on MISSE-1 and MISSE-2. Solar absorptance and infrared emittance measurements are given for thermal control materials. Transmission measurements are given where appropriate.

Miria M. Finckenor

NASA/Marshall Space Flight Center

National Space and Missile Materials Symposium Henderson, NV June 2009

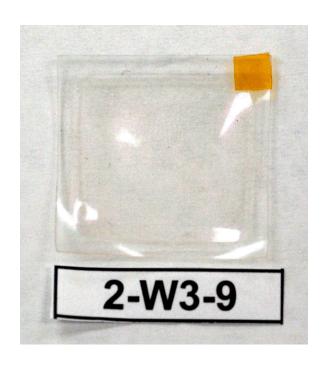
- Used in refractive photovoltaic concentrator systems
- Four samples flown on MISSE-2 wake side
 - Two with UV-rejection coating
 - Two without coating
- Three samples flown on MISSE-4 wake side
 - •Two with UV-rejection coating
 - •One without coating
- Consistent results between flights
 - Samples without coating darkened
 - •Samples with UV-rejection coating maintained similar transmission

Typical coated sample

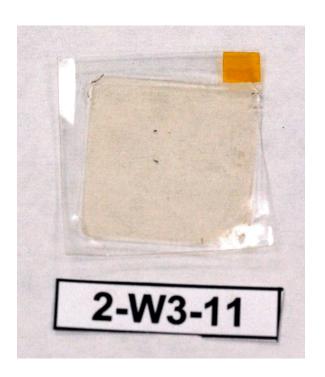
Typical uncoated sample

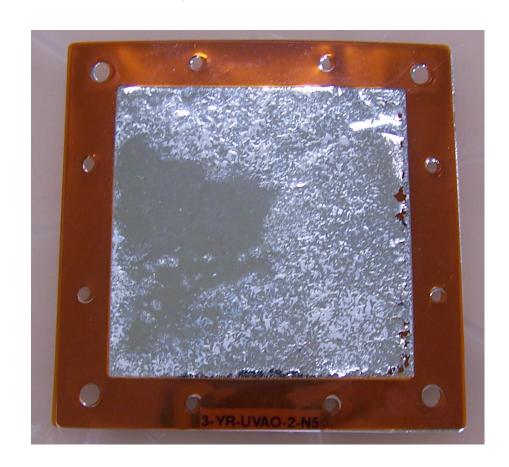
1 mil CP1 with aluminum and SiOx coating

- Exposed to 1.3 x 10²¹ atoms/cm² AO
- Some erosion through film

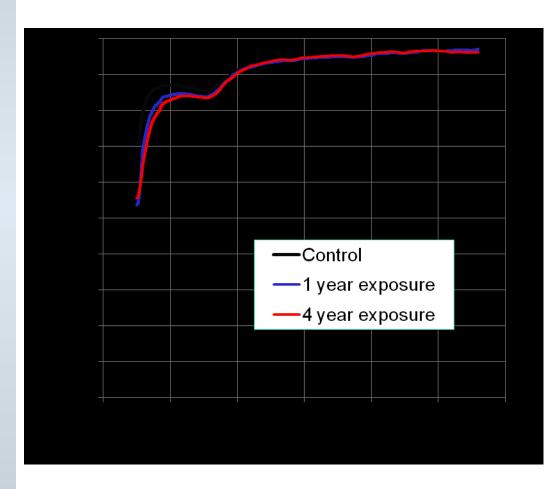
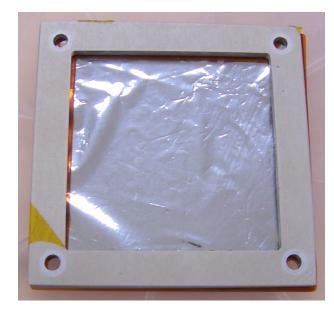
1 mil CP1 with aluminum coating

• Some oxidizing of aluminum coating noted

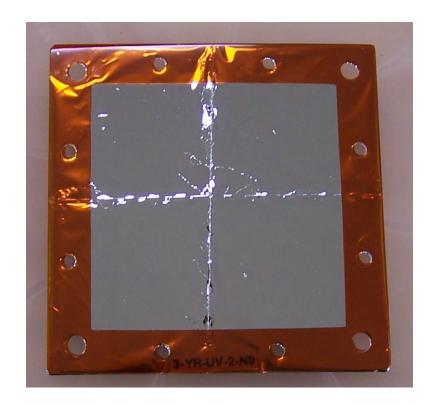
5 micron CP1 with Al and SiOx coating and ripstop

- Some oxidizing of aluminum coating noted
- Ripstop intact

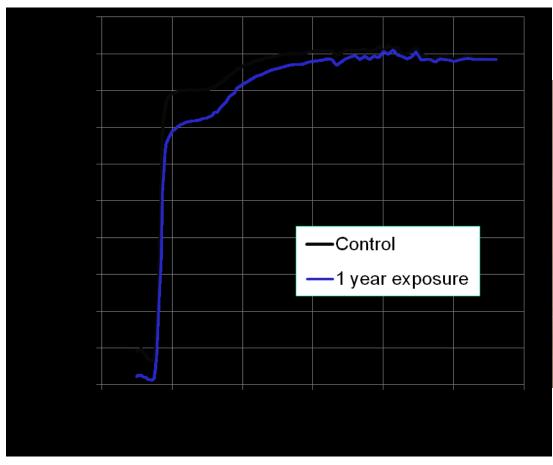
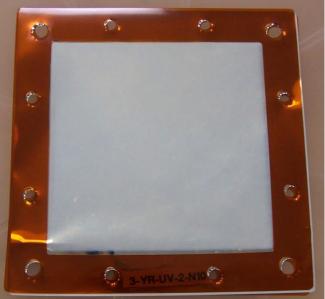
1 mil CP1 with aluminum coating

- CP1 side exposed
- AO erosion evident emittance dropped from 0.65 to 0.61

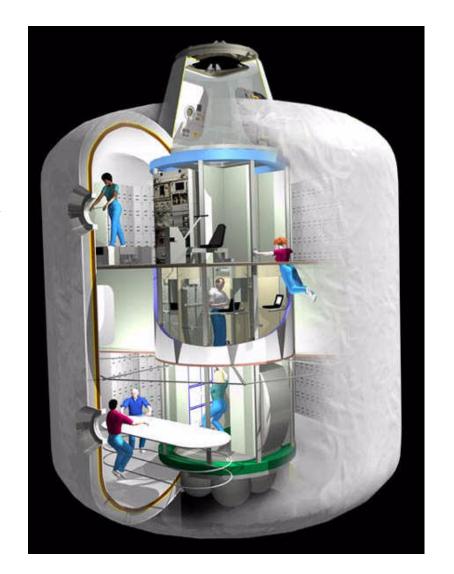
Polyurethane foam, Combitherm bladder material, Kevlar felt, Kevlar webbing

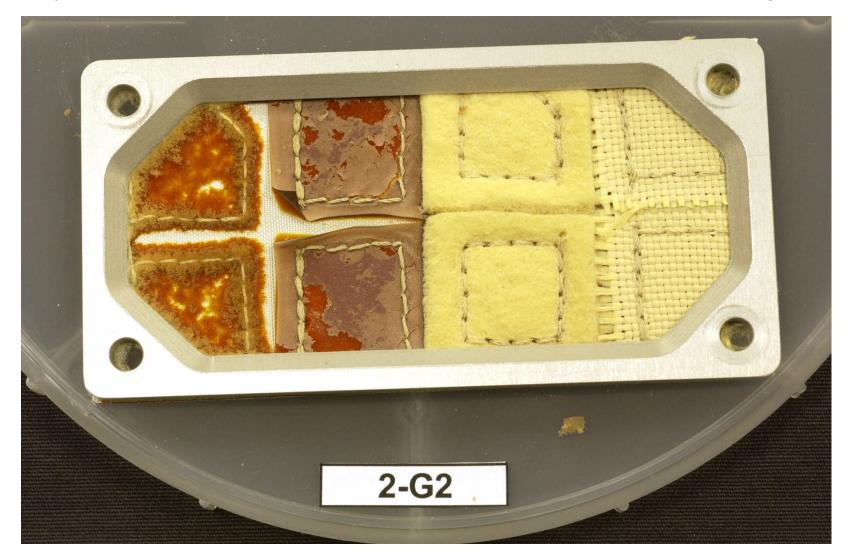
- Foam and bladder materials heavily eroded
 - No AO reactivity calculated
- Kevlar materials, including thread intact, after four years
- Nextel intact (one year exposure)
- Sizing appears to be removed

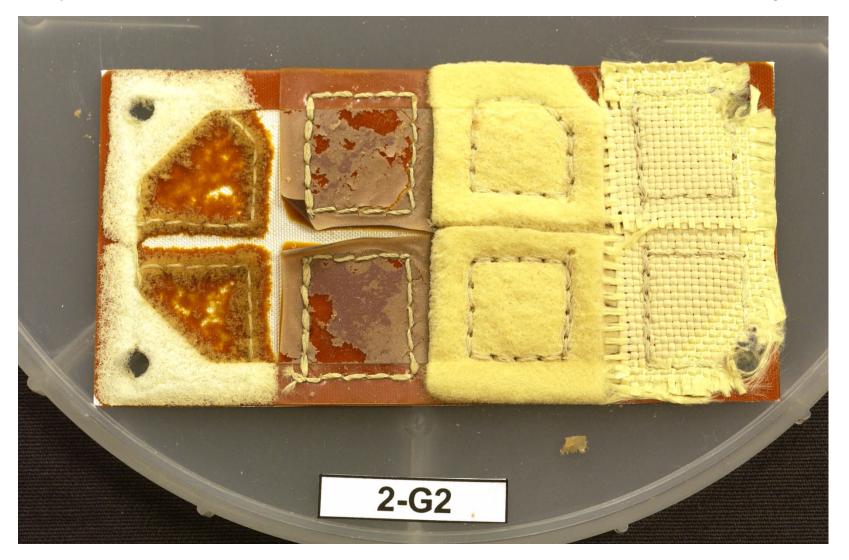
Polyurethane foam, Combitherm bladder material, Kevlar felt, Kevlar webbing

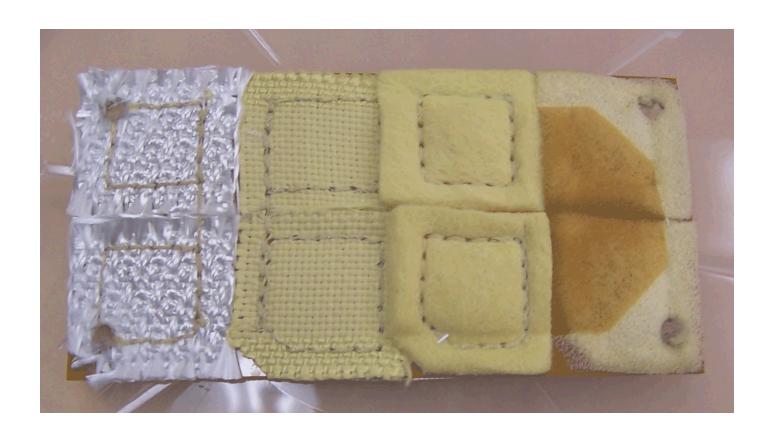
Nextel cloth, Kevlar webbing, Kevlar felt, polyurethane foam

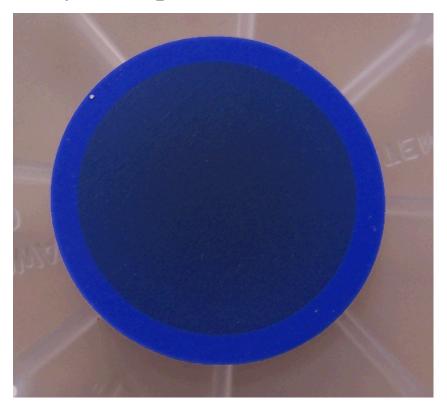
Fluorosilicone

- Little mass loss
 - 1.5 mg (0.13%) for four-year exposure
- Darkened due to UV
- Some glassification

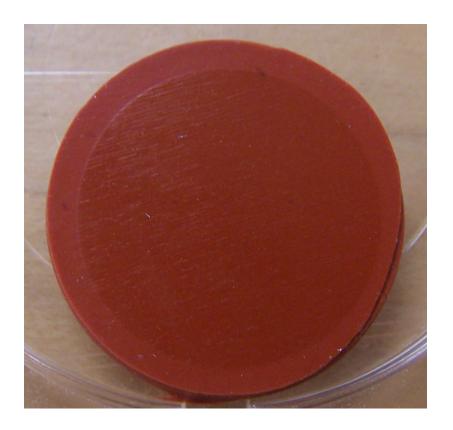
Seal Materials Silicone S383

- Mass increase with the formation of SiOx
- Cracking evident

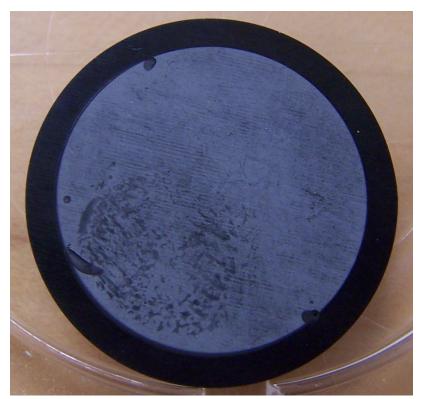
Seal Materials Viton 835

- Some mass loss
 - 3.7 mg (0.32%) for one-year exposure
- Calculated AO reactivity 0.26 x 10⁻²⁴ cm⁻³/atom

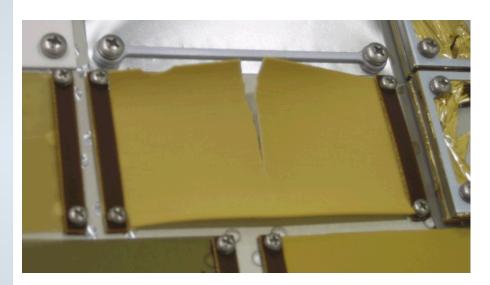
Other Polymeric Materials Boeing Dielectric Film Withstood AO attack, too brittle for much analysis
